PROJECT PROFILE

John Hancock Center

Swing Stage Collapse Investigation | Chicago, IL

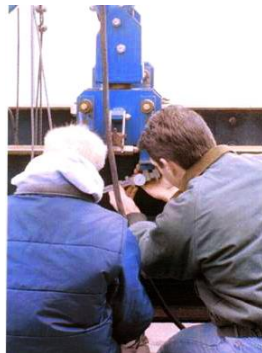
In 2002, a swing stage that was parked overnight on the forty-second floor of the west elevation collapsed during a severe wind storm. Debris from the collapse fell onto the surrounding streets and plaza at the base of the building, fatally injuring four people in cars and severely injuring several people on the sidewalks and streets. Attorneys representing the architectural firm that designed the repair work being performed on the facade of the building at the time of the swing stage collapse retained WJE to determine the cause of the collapse.

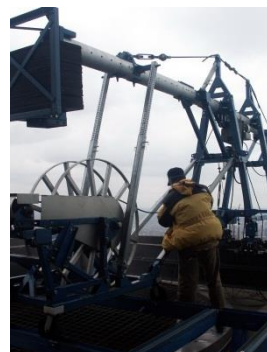
WJE tested facsimile undercarriage wheels, conducted a wind tunnel performance test on a 1:300 scale model of the building with the swing stage platform, and performed structural wind load analysis of the collapsed swing stage. Finally, the engineers reviewed information produced within the litigation process.

Based on the investigation, WJE concluded that the collapse occurred as a result of the failure of undercarriage wheels and cable tie down system on the rear leg of the outriggers due to forces caused by downward wind pressure on the platform of the swing stage system. It was also concluded that the architect's repair design did not contribute to the collapse. The City of Chicago enacted a scaffolding ordinance for buildings greater than eighty feet in height approximately five months after the accident occurred.
